SESSION 3

Inspection and Maintenance of Dams and Spillways

Inspection of a dam

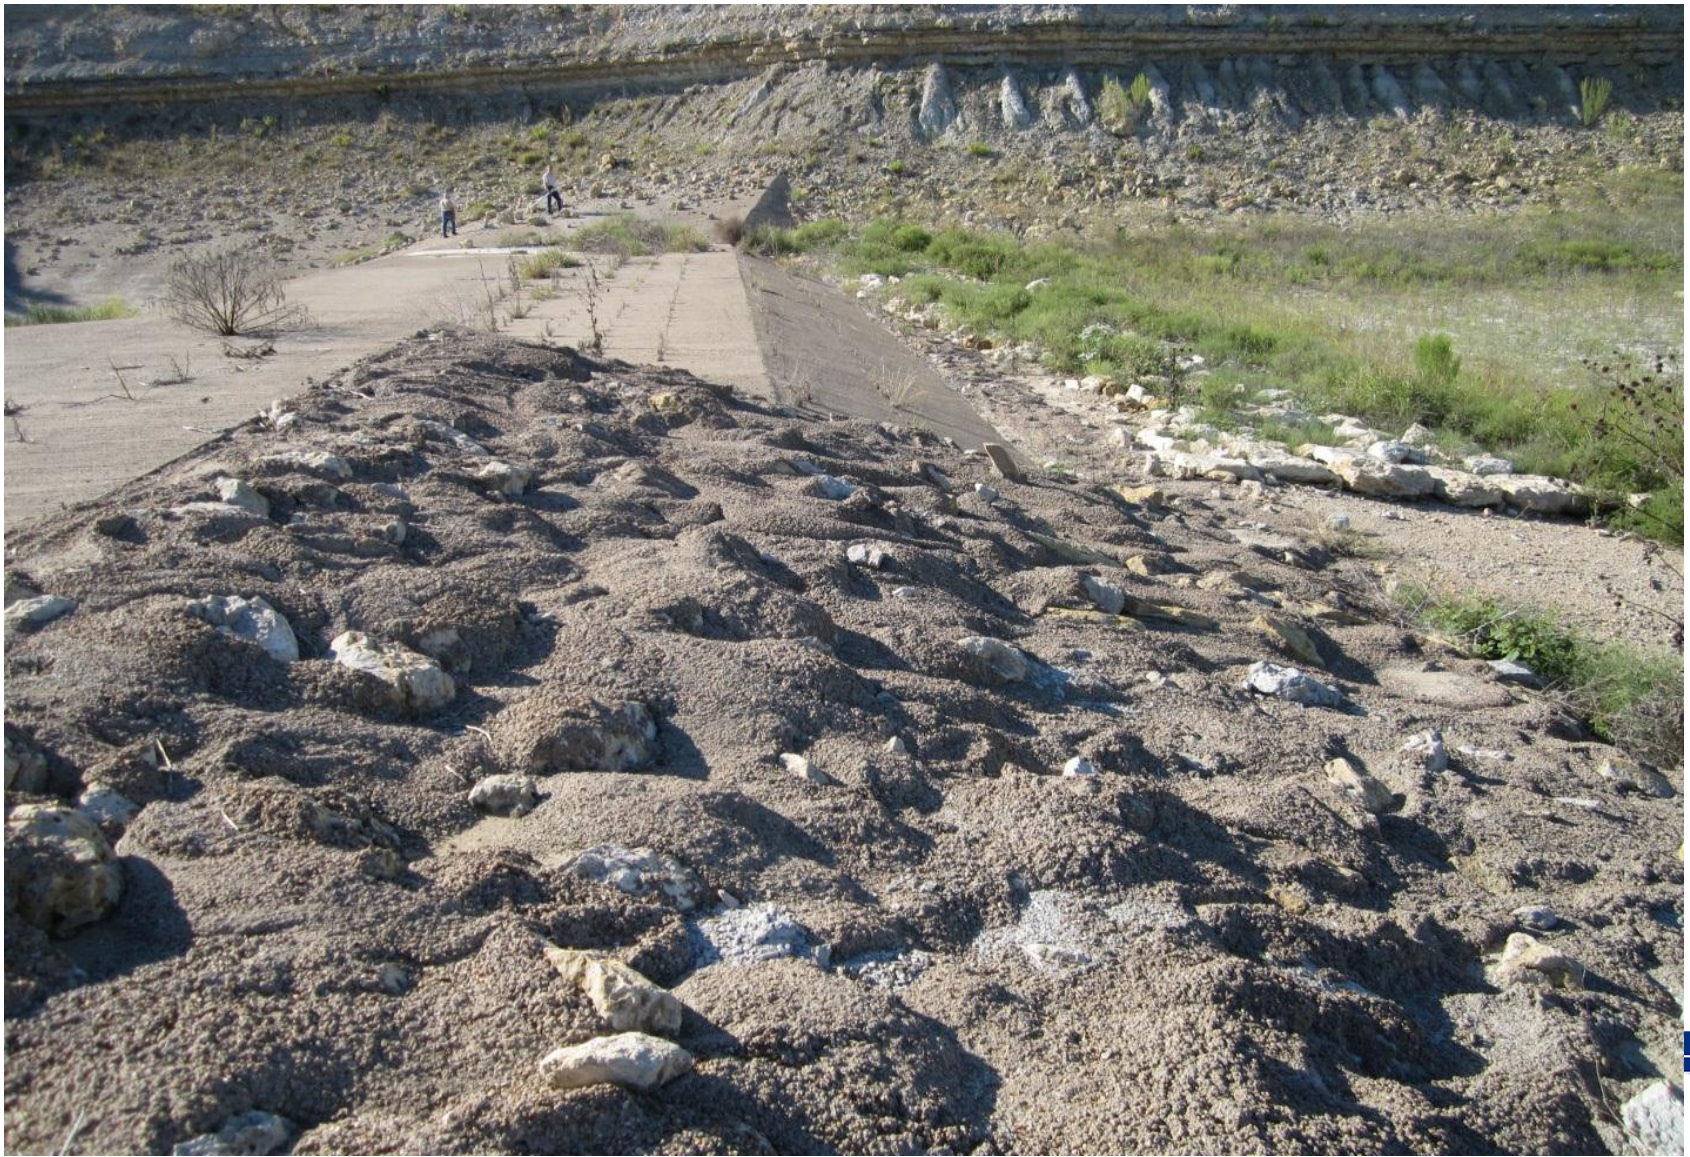
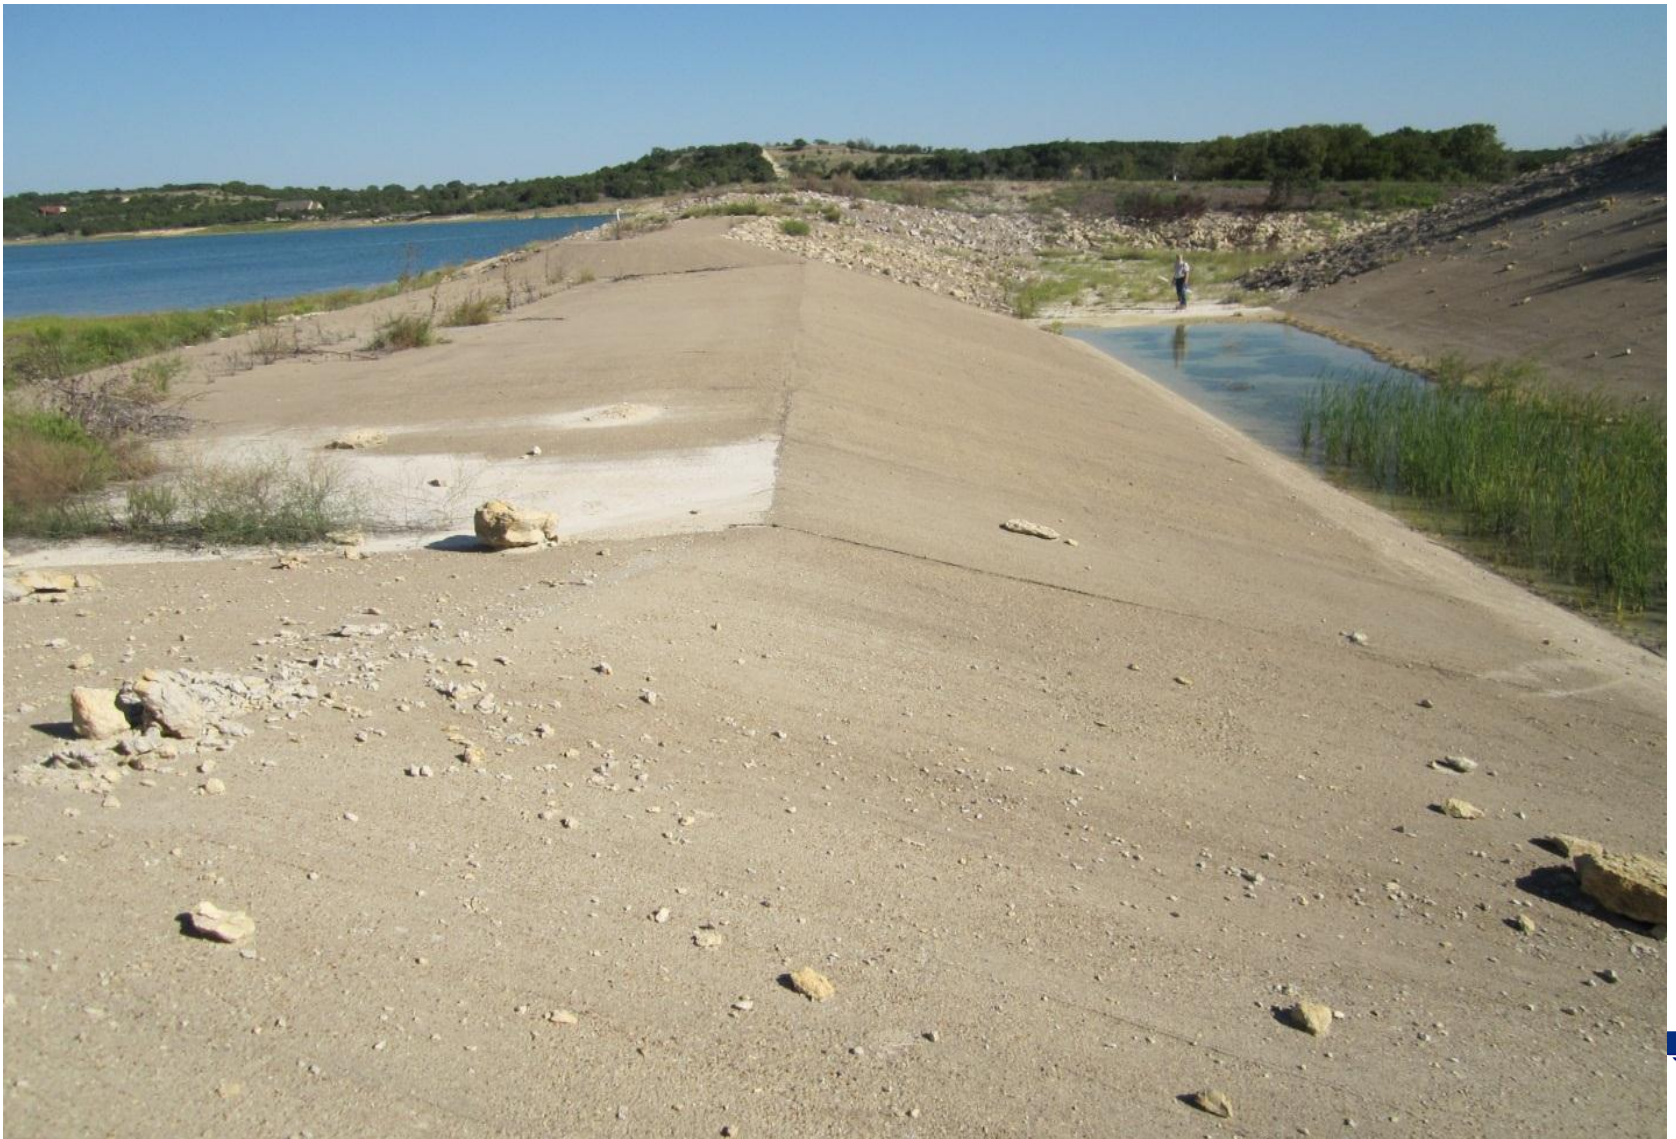
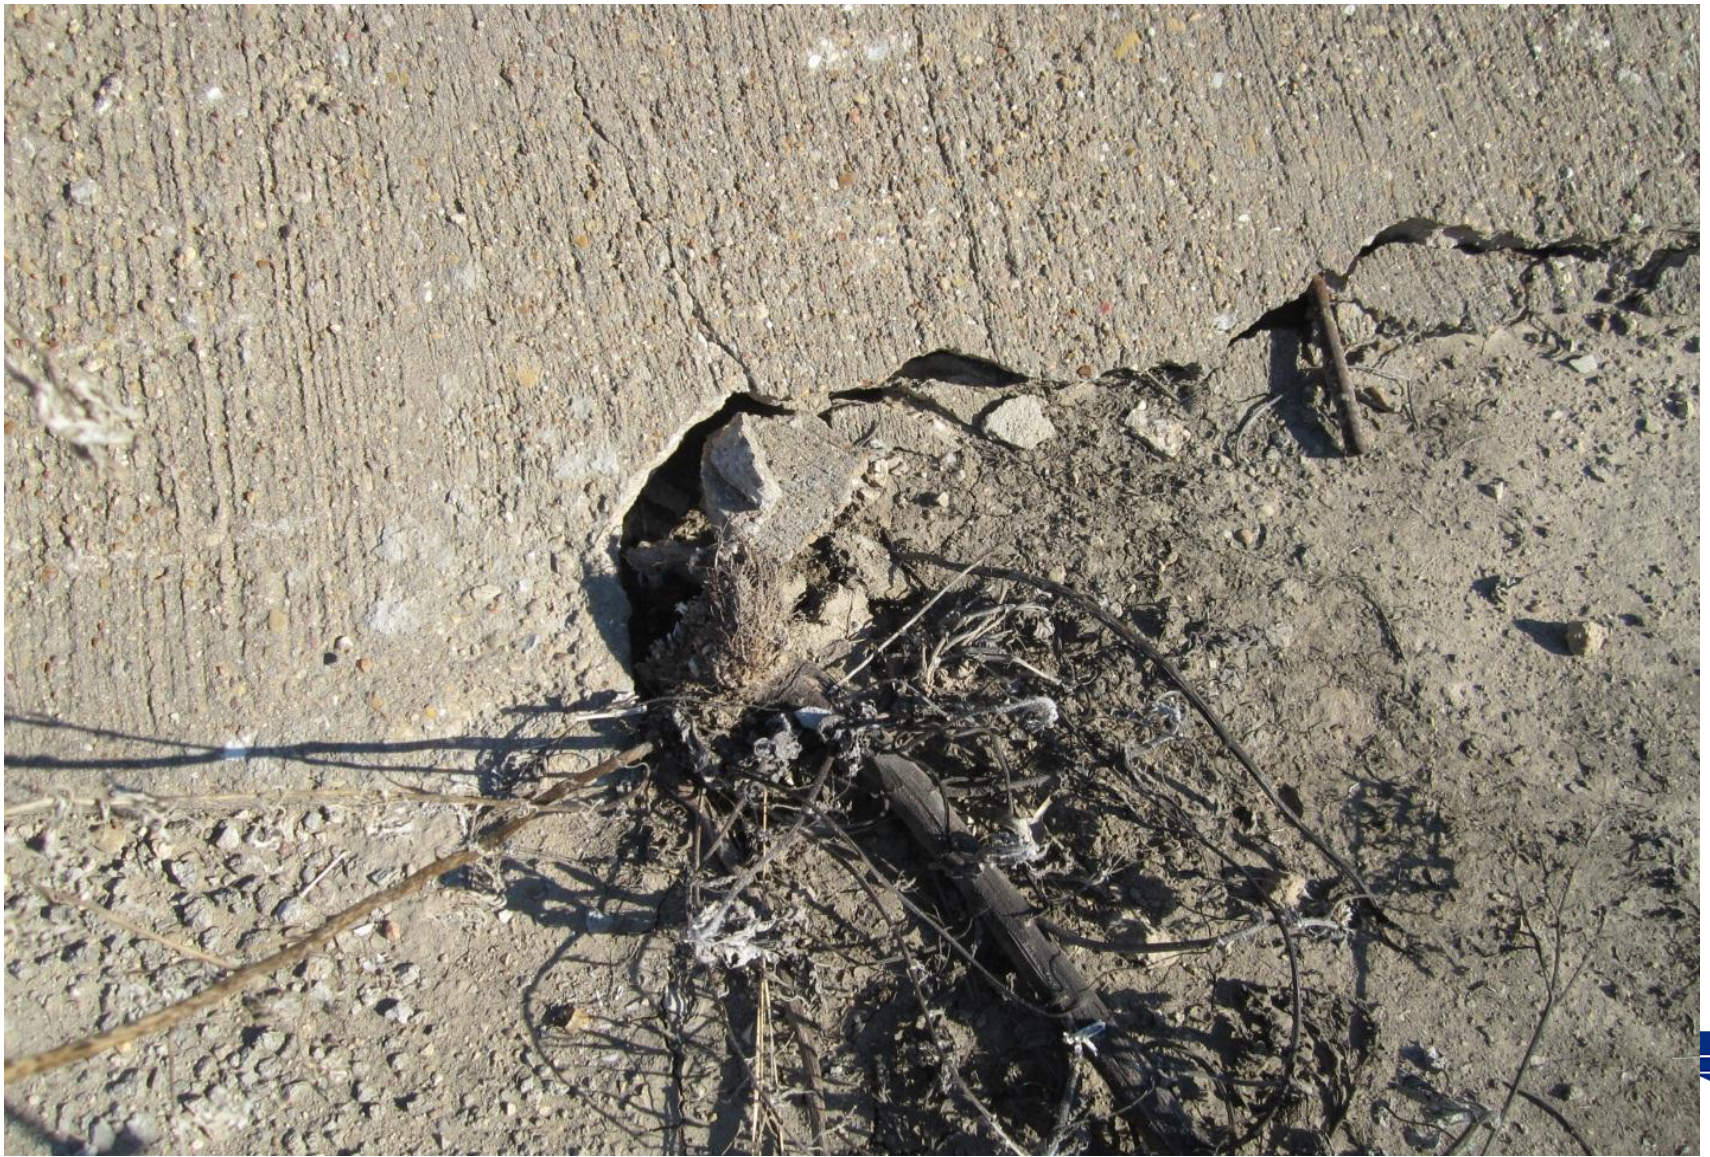
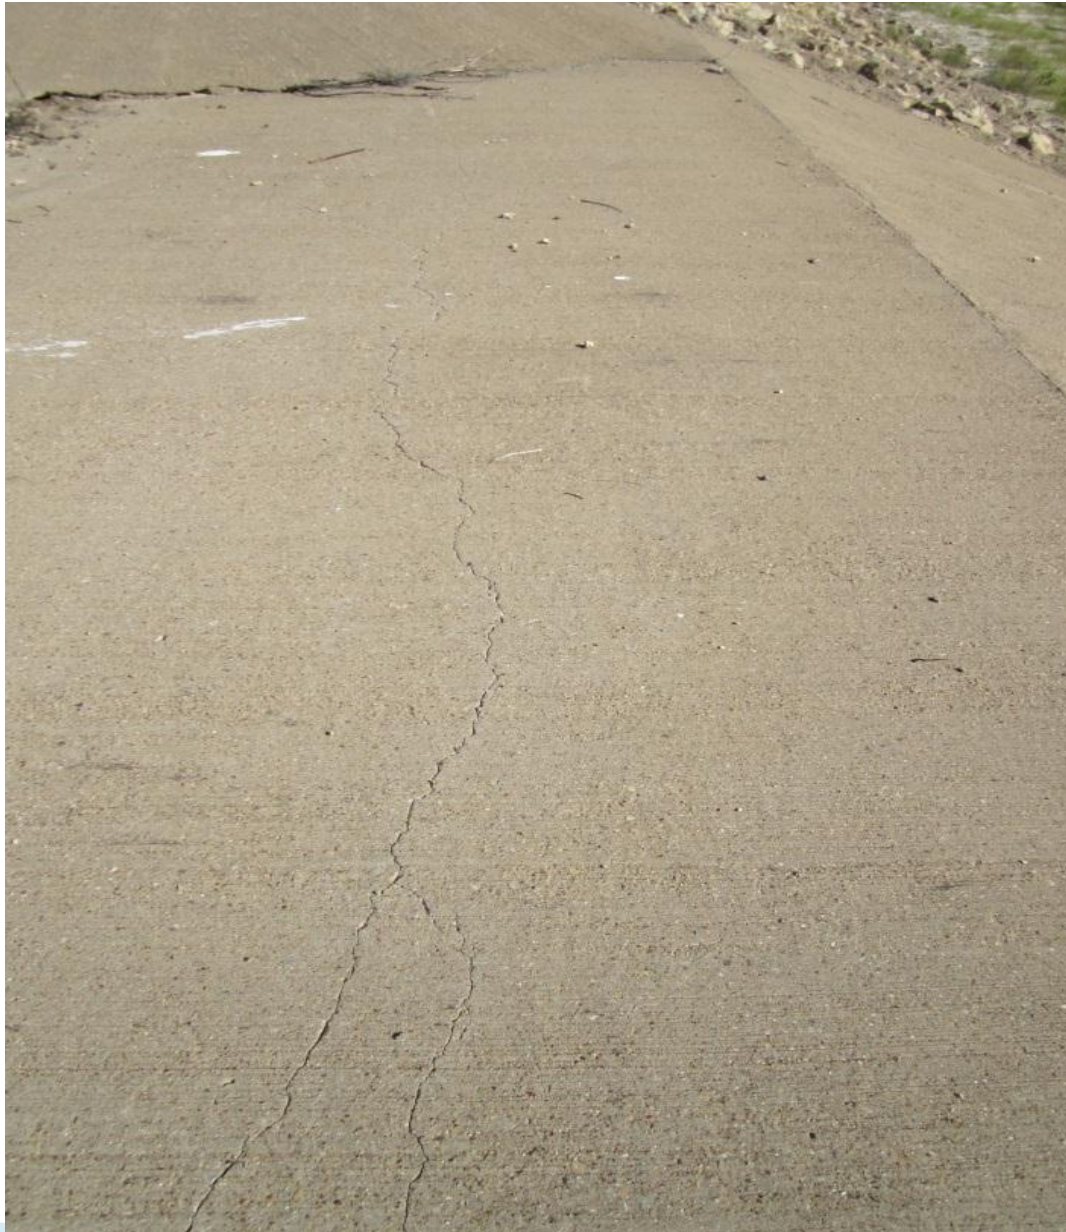
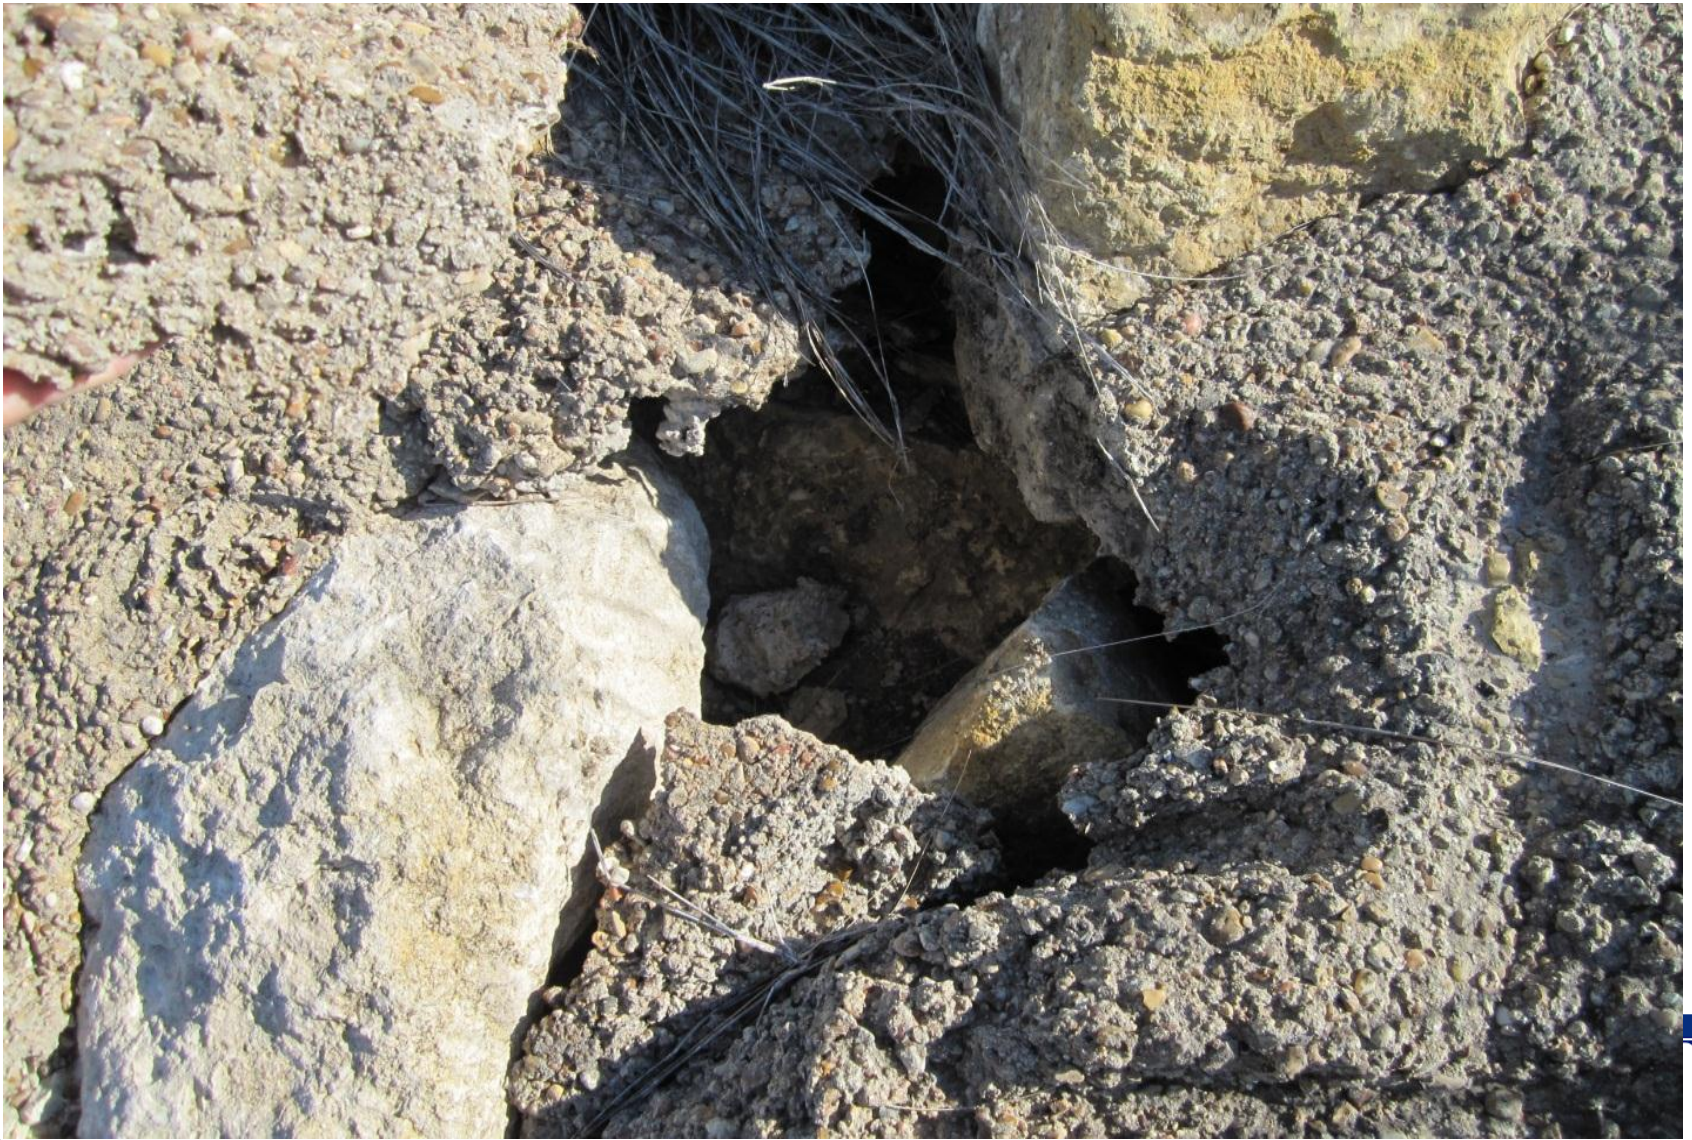
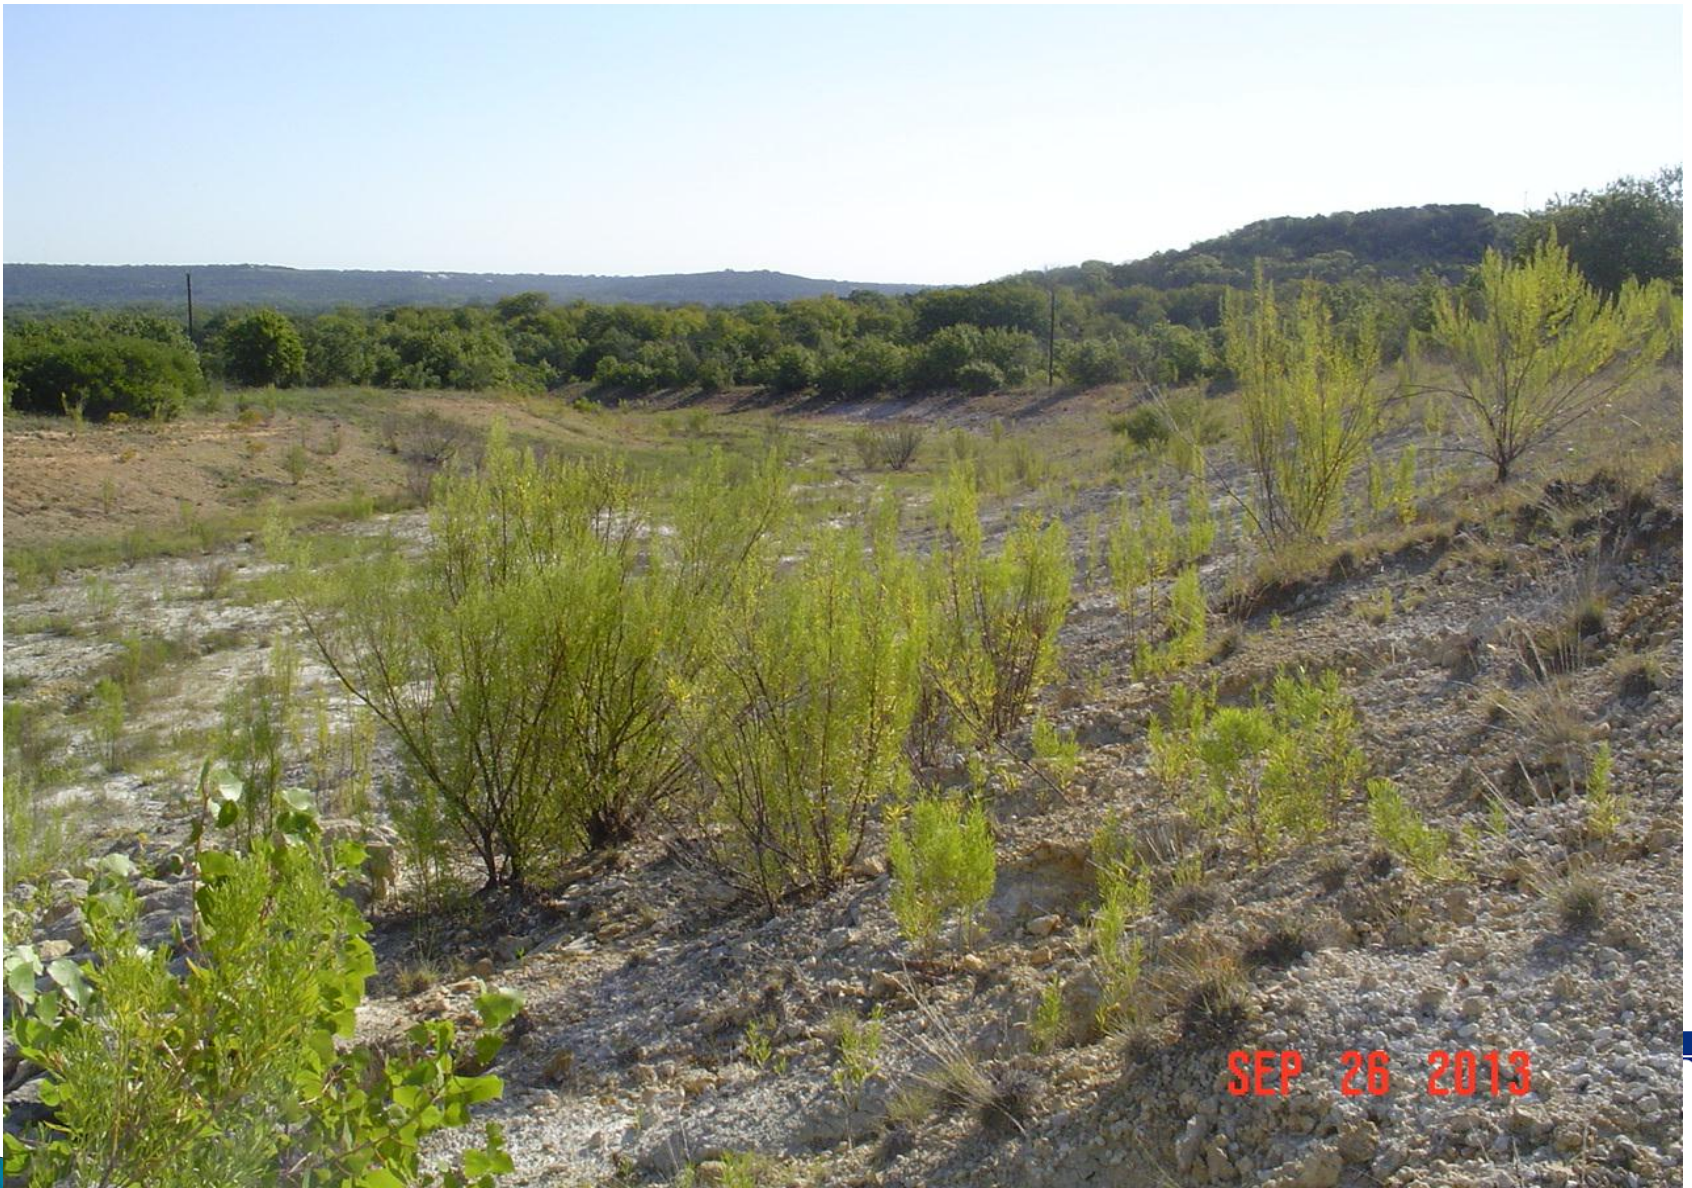
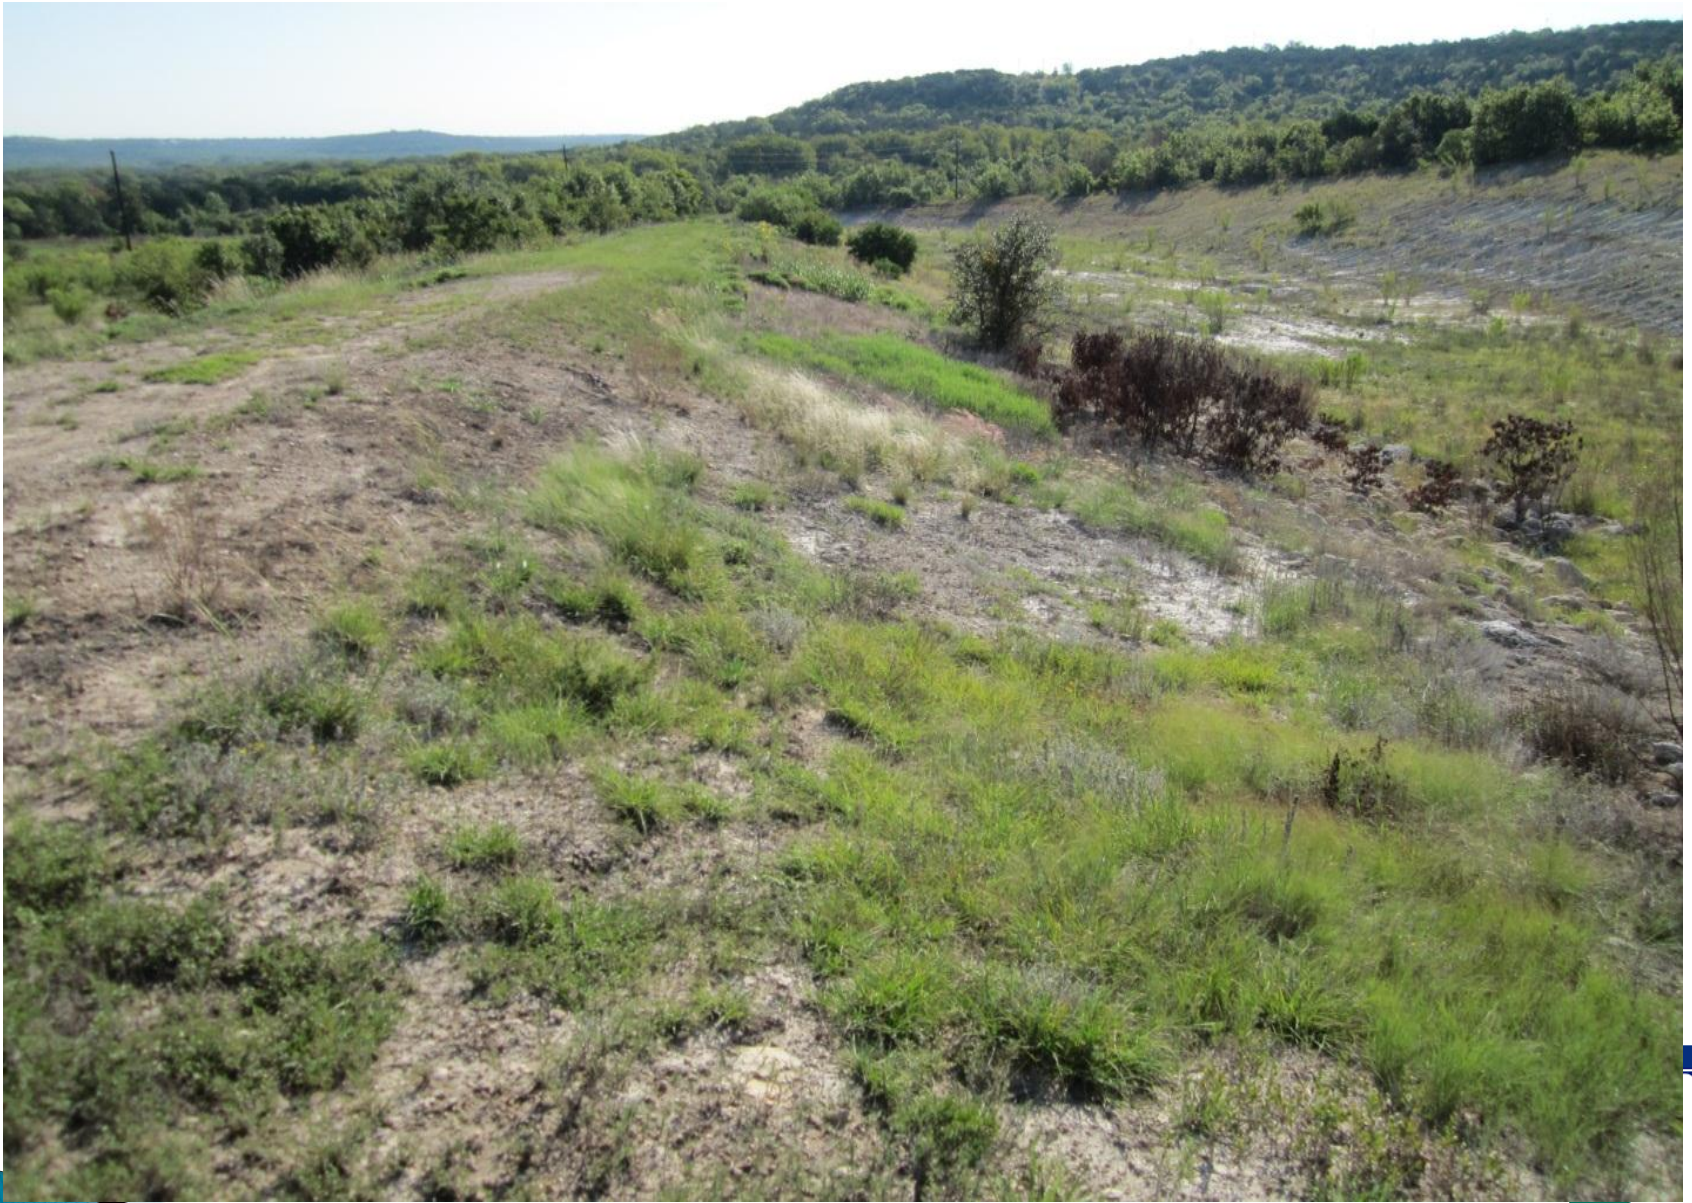
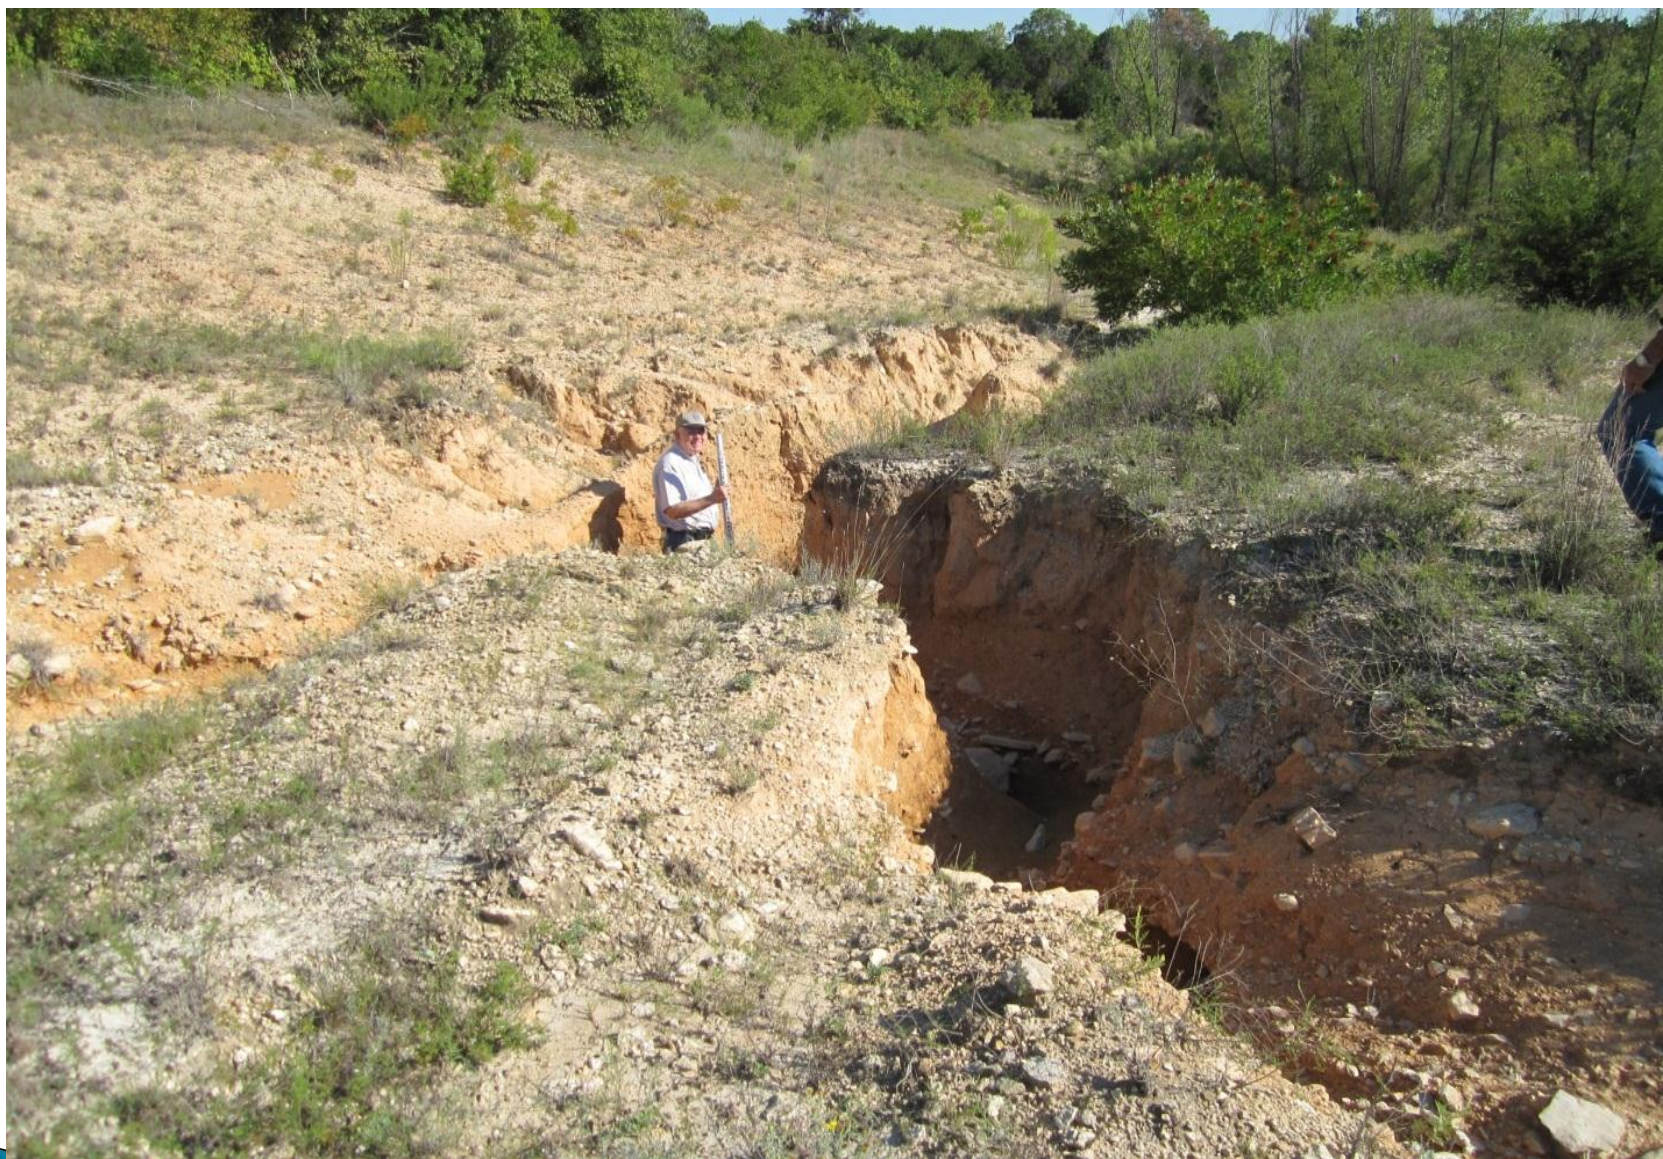
Spillways

- ▶ Vegetation in the joints, cracks, and pressure relief holes
- ▶ Cattails in the spillway stilling basin
- ▶ Rocks falling on the concrete
- ▶ Cracks in the concrete
- ▶ Voids in the emergency spillway protection
- ▶ Trees in the channel and on the side slopes
- ▶ Erosion in the channel and on the side slopes

- ▶ The trees in the spillway should be removed. A periodic removal schedule should be established and followed.
- ▶ The vegetation in the joints and pressure relief vent holes in the spillways should be cleared, and the joints and holes should be maintained clear of vegetation. The joints should then be sealed.
- ▶ The cracks in spillways should be monitored and sealed as necessary.

- ▶ The cattails in the service spillway stilling basin need to be removed.
- ▶ The rock that has fallen on the service spillway and the side slopes should be removed periodically. Flow through the spillway can cause damage to the spillway due to the rocks. The concrete should be inspected during the removal process to detect any damage to the concrete from the rocks falling on the concrete.

- ▶ The erosion in the spillway discharge channel has increased in size due to rainfall runoff. Some of the gullies have become quite deep. The erosion should be repaired, and some type of protection placed. An inspection should be made if there is ever a flow through the spillways.
